# A Study of Spur Gears Lubricated With Grease-Observations From Seven Experiments

Timothy L. Krantz and Robert F. Handschuh U.S. Army Research Laboratory, Glenn Research Center, Cleveland, Ohio

Prepared for the 58th Meeting of the Society for Machinery Failure Prevention Technology (MFPT) cosponsored by ONR, NASA, ARL, NAWC, and NSWC Virginia Beach, Virginia, April 26–30, 2004

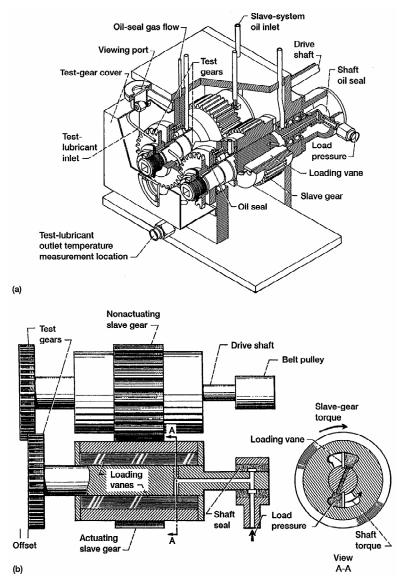
Figure 1.—NASA Glenn Research Center gear fatigue test apparatus. (a) Cutaway view. (b) Schematic view.

The experiments were conducted using the NASA Glenn Research Center Spur Gear Fatigue Test Rigs. These test rigs have been used for more than 30 years to test oil lubricated spur gears, with emphasis on studying contact fatigue (spalling, pitting, and micropitting). The test rig as shown in Figure 1(a) uses the four-square (torque-regenerative) principle of applying test loads, and thus the motor needs to overcome only the frictional losses in the system. The test rig is belt driven using a variable speed electric motor with a belt and pulley system. A schematic of the loading apparatus is shown in Figure 1(b). Hydraulic oil pressure and leakage replacement flow is supplied to the load vanes through a shaft seal. As the oil pressure is increased on the load vanes located inside one of the slave gears, torque is applied to its shaft. This torque is transmitted through the test gears and back to the slave gears. In this way power is circulated, and the desired load and corresponding stress level on the test gear teeth may be obtained by adjusting the hydraulic pressure.

Figure 1 depicts the spur gear rig as has been used for tests operated at 10,000 rpm for the purpose of evaluating the fatigue lives of oil lubricated gears. The test setup as used for the grease tests reported herein differed from the depiction of Figure 1 in two important ways. Figure 1 illustrates the test gears operating with faces offset. The face-offset condition is used to concentrate the Hertz contact stress as is desired for accelerated life testing of high cycle fatigue. For the grease lubricated gear testing, the gears

were operated with zero offset (full faces in contact with each other). Also, Figure 1 depicts pressurized labyrinth seals on the two shafts. For the grease testing reported herein, lip seals were used on the two shafts to prevent leakage of the slave gear lubricating oil to the grease lubricated test gear section. The lip seals have used with much success on these rigs to maintain zero-leakage even for speeds of 10,000 rpm. Testing reported herein was done at speeds no greater than 705 rpm.

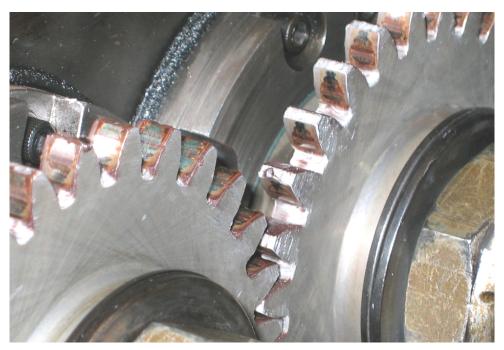
Figure 2.—Condition of the test gears after 3 hr of operation for test number 1 having test conditions of perfluoro type grease, 515 rpm shaft speed, 5 ft-lb torque, and ambient air atmosphere.

The first grease test was conducted at 5 ft-lb of torque, ambient air, and a speed of 515 rpm. Red colored debris was present after 1 hr of operation. Figure 2 documents the appearance of the test hardware after 3 hr of operation. Significant wear was observed, and the grease and contact areas of the gears have a red color. The test was then run an additional 26 hr unattended. The total test duration in terms of shaft revolutions was 927,000. At the completion of the test, a significant amount of red "dust" covered the test chamber, shafts, and gear teeth sides (Fig. 3). The grease was discolored, including some red colored grease. It is not known at this time if the red grease samples contain red colored wear debris or if the red color also indicates some chemical breakdown of the grease. Grease samples were collected and stored for post-test evaluations.

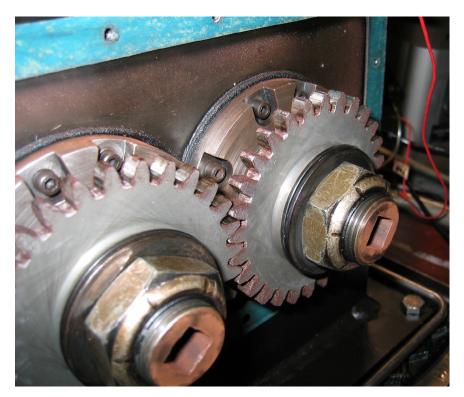
Figure 3.—Condition of the test gears after 30 hr of operation for test number 1 having test conditions of perfluoro type grease, 515 rpm shaft speed, 5 ft-lb torque, and ambient air atmosphere.

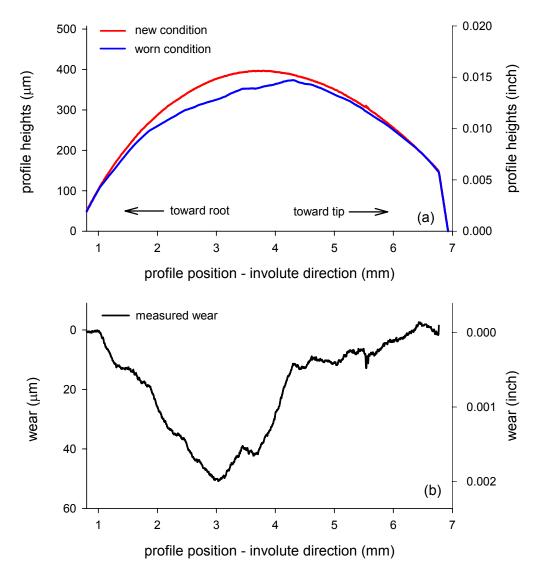
Figure 4.—Analysis of profilometry traces of a gear tooth in the profile direction reveal significant wear during test number 1. (a) Profile traces of tooth number 1 on gear 6-28-2A (the driving gear) at approximately the middle of the tooth face width measured before and after testing. (b) Wear depths determined as the difference of the new and worn profiles.

Profilometer inspections of a gear tooth made in the profile direction both before and after test number 1 revealed significant wear of the tooth surface (Fig. 4(a)). By overlaying the tooth traces to match-up the profiles in non-contacting areas and then subtracting the tested profile from the new profile, wear as a function of position along the tooth profile was determined (Fig. 4(b)). Maximum wear depths occurred in the dedendum (root region) below the pitch line, and wear depth amounts were on the order of  $50 \mu m (0.002 \text{ in.})$ . The measured wear depth is quite significant, about four times the tolerance for the profile for an AGMA (American Gear Manufacturer's Association) class 10 gear of this size.

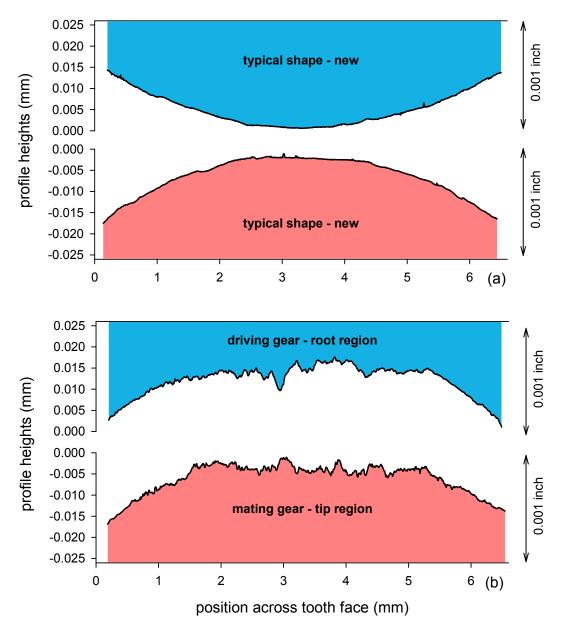
Figure 5.—Profilometry traces of a gear teeth in the lead direction reveal that the original crowned geometry is significantly changed with increase of roughness due to wear during test number 1. (a) Typical measurements of gear teeth before running shows crowned lead geometry. (b) Measurements of mating teeth after running show that the crowned geometry of the mating gear's tip region has been worn into the driving gear's root region.

Profilometer inspections of gear teeth were also made in the lead direction (across the tooth face). Before testing, gear tooth surfaces were all of a crowned, convex shape in the lead direction (Fig. 5(a)). Measurements of mating gear teeth after testing revealed that the convex shape of the mating gear's tooth tip region has worn a concave shape into the root region of the driving gear (Fig. 5(b)). It is also of significance that the worn surfaces are much rougher than the original ground gear surfaces. The increased roughness will promote higher wear rates and will tend to increase vibration.

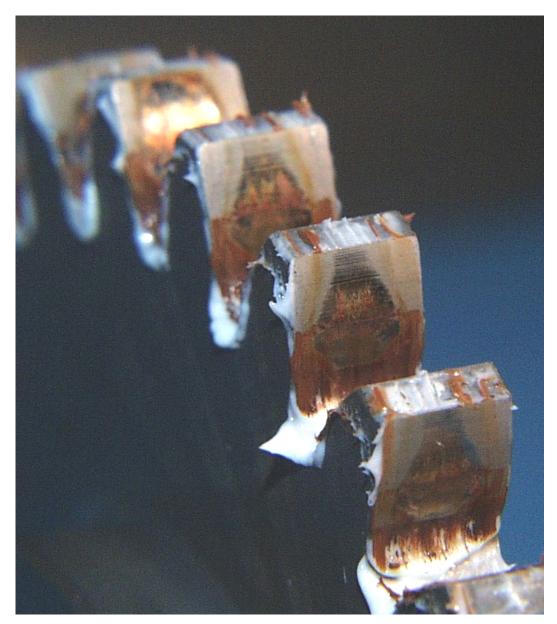
Figure 6.—Condition of the driven gear after 15 hr of testing for test number 2 having test conditions of perfluoro type grease, 200 rpm shaft speed, 2 ft-lb torque, and ambient air atmosphere. A mixture of original white and red colored grease is evident along with wear patterns.

The second perfluoro type grease lubricated gear test was conducted at 2 ft-lb of torque (less torque than test number 1) and in ambient air. The test was run with shaft speed of 200 rpm. To provide a more complete evaluation of test progression, the testing was temporarily stopped after 15, 30, and 60 min. of cumulative testing time. When the test was stopped temporarily, the cover was removed for close inspections of the working tooth surfaces. Inspections after the 15 and 30 min. test durations revealed only the appearance of the expected contact patterns. No discolored debris or grease was observed. However, at the completion of 60 min. total test duration, the centers of contact patterns of the working surfaces of some teeth had some red colored areas. Most of the grease still had the original white color at that time. The test was then restarted and run for an addition 15 hr unattended. At completion of 194,000 shaft revolutions, the test was stopped. A significant amount of red debris and red colored grease was present at the end of the test (Fig. 6).

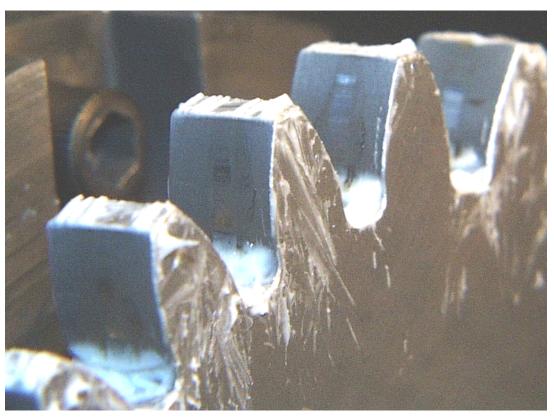
Figure 7.—Condition of the driven gear after 18.5 hr of testing for test number 3 having test conditions of perfluoro type grease, 214 rpm shaft speed, 2 ft-lb torque, and dry nitrogen atmosphere.

grease was generated during this third test. The duration of the test was 18.5 hr and comprised 238,000 shaft revolutions, somewhat longer than the equivalent test done in ambient air. The gear contact patterns reveal that, as expected, some wear occurred during this test number 3 (Fig. 7). Some grey grease streaks were observed on the tips of some of the gear teeth after completion of the tests. The composition of the grey streaks is not known at this time.

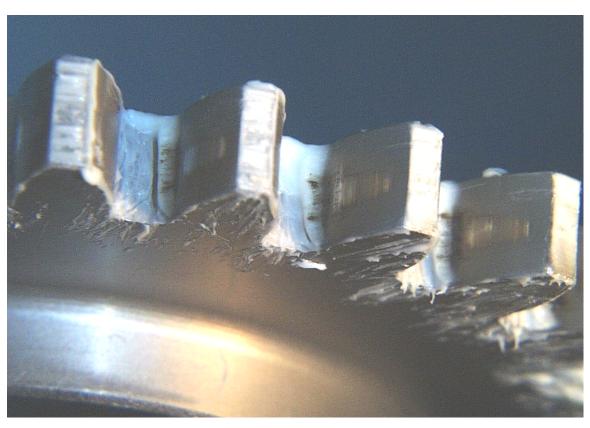
Figure 8.—Condition of the driven gear after 16 hr of testing for test number 4 having test conditions of perfluoro type grease, 214 rpm shaft speed, 5 ft-lb torque, and dry nitrogen atmosphere.

The fourth perfluoro type grease lubricated gear test was conducted to closely match the speed and torque of grease test number 1. However, for this test the chamber contained a dry nitrogen atmosphere. The test torque was the higher of the two test torques (5 ft-lb). Once again, the test was not stopped for occasional close inspection of the teeth to avoid introducing air and moisture into the test chamber. The total test duration was 16 hr and comprised 205,000 shaft revolutions. At the end of the test there was a mixture of original white and dark-grey colored grease (Fig. 8). The grey colored grease tended to be collected in the roots of the driven gear and towards the tips of the driving gear, suggesting that the dark color is due to wear debris that has been pushed to the end of tooth contact. At this time, it is not known if the discoloration is only due to wear debris, chemical degradation of the grease, physical separation of oil and grease base, or some combination of these phenomena.

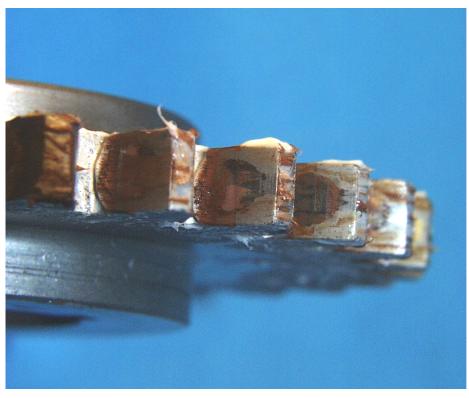
Figure 9.—Condition of the driven gear after 16 hr of testing for test number 5 having test conditions of perfluoro type grease, 214 rpm shaft speed, 5 ft-lb torque, and dry air atmosphere.

The fifth perfluoro type grease lubricated gear test was conducted to closely match the speed and torque of grease test number 4 (the test just described in preceding text). The test torque was the higher of the two test torques (5 ft-lb). For this test the chamber contained a dry air atmosphere while for the previous test the chamber contained a dry nitrogen atmosphere. The "Test Procedure and Operating Conditions" section of this report describes the manner for introducing flows of dry gas. The test chamber cover was not removed for the duration of the test to avoid introducing moisture into the test atmosphere. The front cover of the test chamber was a clear plate that permitted observation of the gear teeth. The test was stopped temporarily after 2 hr of cumulative testing time, and red deposits were observed on the working surfaces of the teeth. After the completion of 16 hr (210,000 shaft revolutions) the gears had a significant amount of discolored grease including red deposits and red grease (Fig. 9). At this time, it is not known if the discoloration is only due to wear debris, chemical degradation of the grease, physical separation of oil and grease base, or some combination of these phenomena.

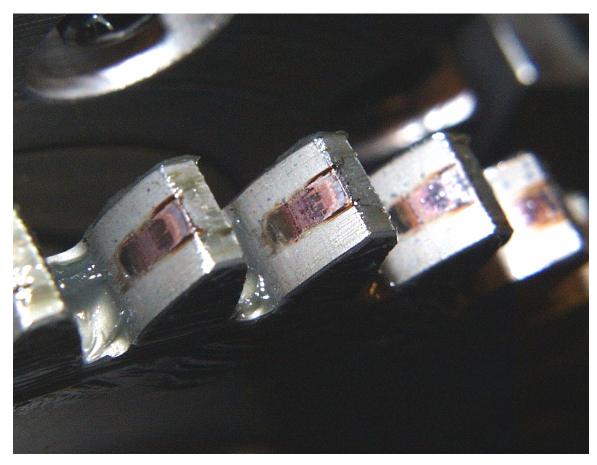
Figure 10.—Condition of the driven gear after 1 hr of testing for test number 6 having test conditions of hydrocarbon-based grade 2 grease, 214 rpm shaft speed, 2 ft-lb torque, and ambient air atmosphere.

To provide a baseline for comparison, one gear test was conducted using a hydrocarbon-based grease. The grease was grade 2 (selected to match the grade of the perfluoro type grease) and described as appropriate for wheel bearings. The test chamber atmosphere was ambient air, and the test load and speed were chosen to provide direct comparison to grease test number 2. A test duration of 1 hr was selected since red coloring within the tooth contact patterns was observed after 1 hr of testing with the perfluoro type grease. After the 1 hr test comprising 13,000 shaft revolutions, red deposits were found on all of the gear teeth contact areas (Fig. 10). Any differences in wear rates or composition of wear debris (as compared to operation with perfluoro type grease) will require further inspections and analysis.

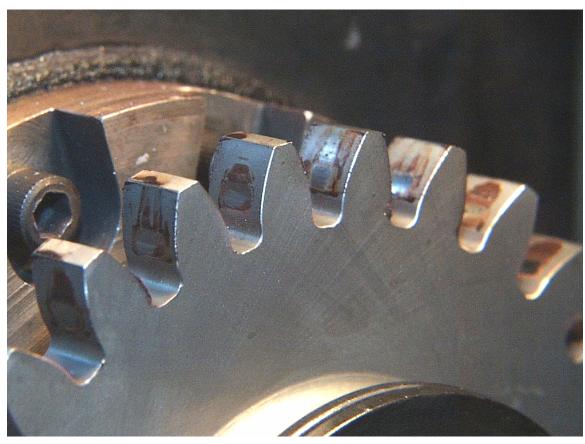
Figure 11.—Condition of the driven gear after 1 hr of testing for test number 7 having test conditions of no lubricant, 705 rpm shaft speed, 2 ft-lb torque, and ambient air atmosphere.

To provide another baseline for comparison, one gear test was conducted using no lubricant on the test gears. The atmosphere was ambient air. The running speed was somewhat higher than for the other testing. The test was conducted for 1 hr comprising 42,000 shaft revolutions. As was expected, wear of the teeth occurred, and red colored wear debris was present at the end of the test (Fig. 11).
